# 超輕型載具檢驗實務

民用航空局 飛航標準組 108年11月24日

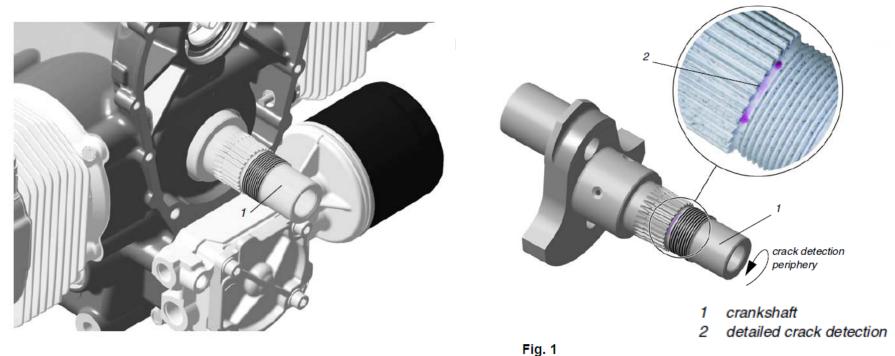
Due to a deviation in the manufacturing process some <u>crankshafts</u> may have a <u>crack</u> formation occur on the power take off side. These cracks can cause a breakage of the crankshaft support bearing and may lead to engine stoppage.

Check of the crankshaft journal (power take off side) for ROTAX® engine type 912 and 914 (Series).

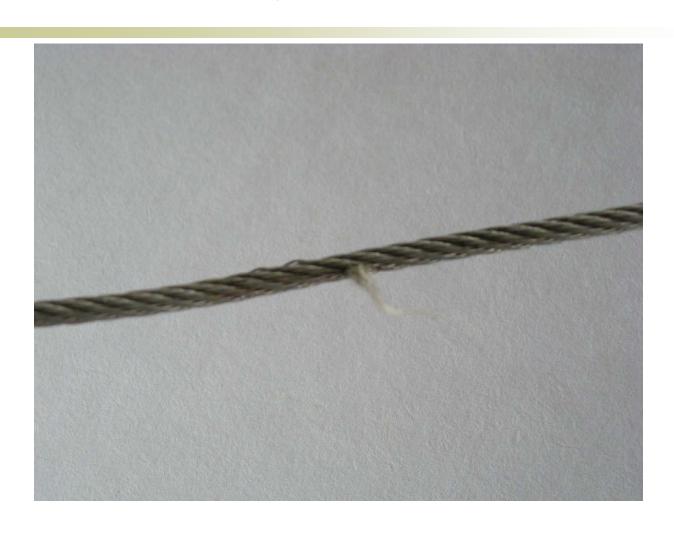
## 鋼繩脫毛

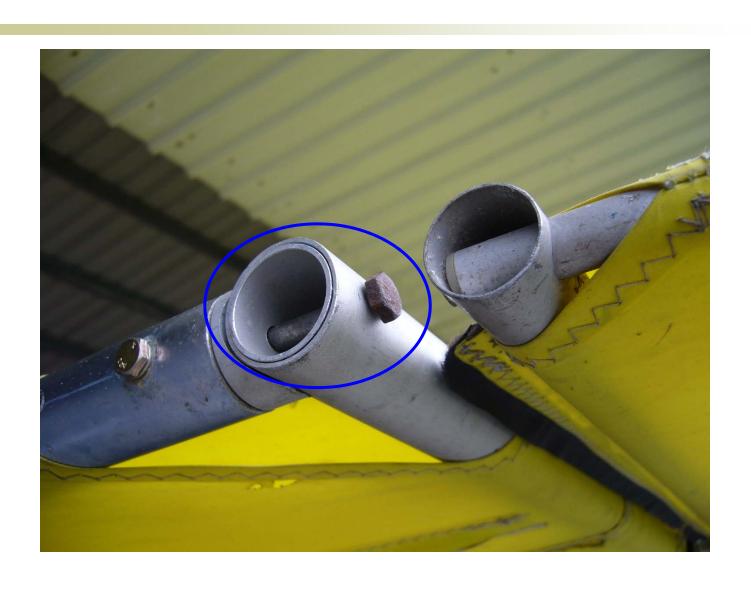
## 接合螺栓銹蝕

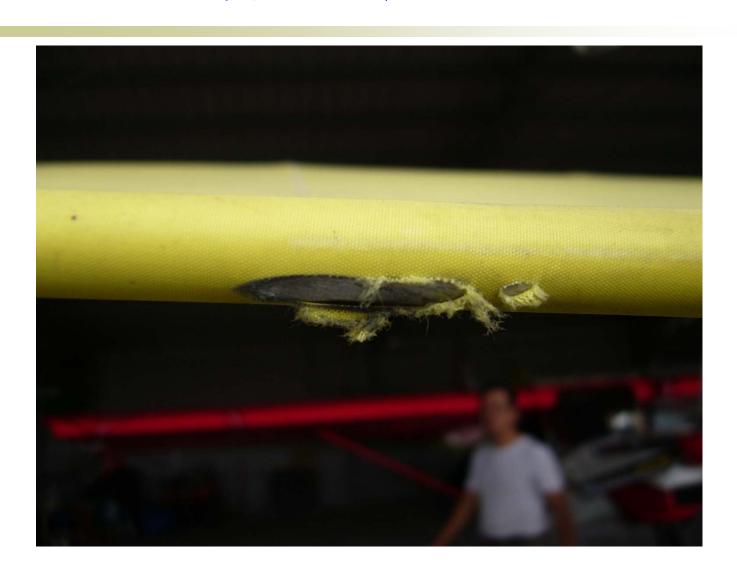
## 翼面帆布破損

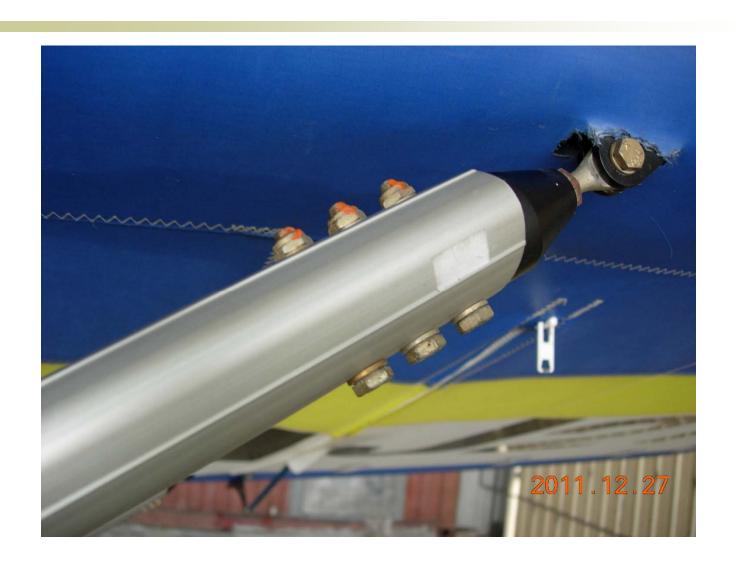
### 機翼固定螺絲安裝反向

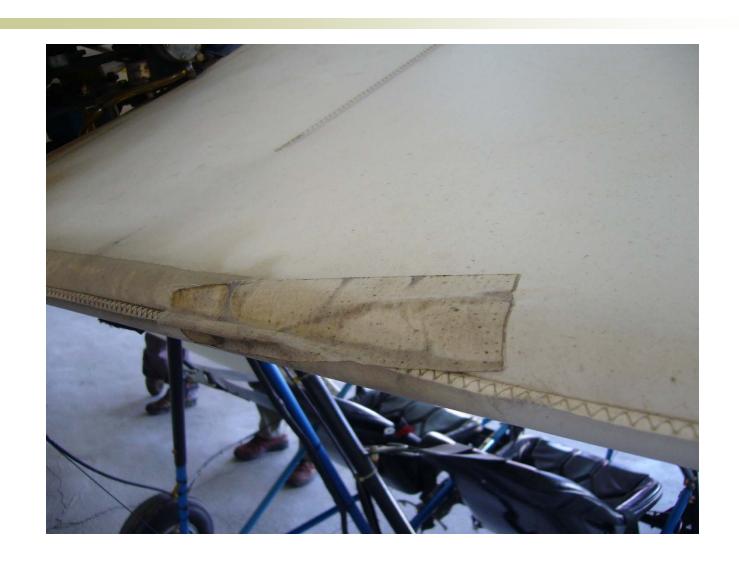
## 未用原材質修補翼面帆布

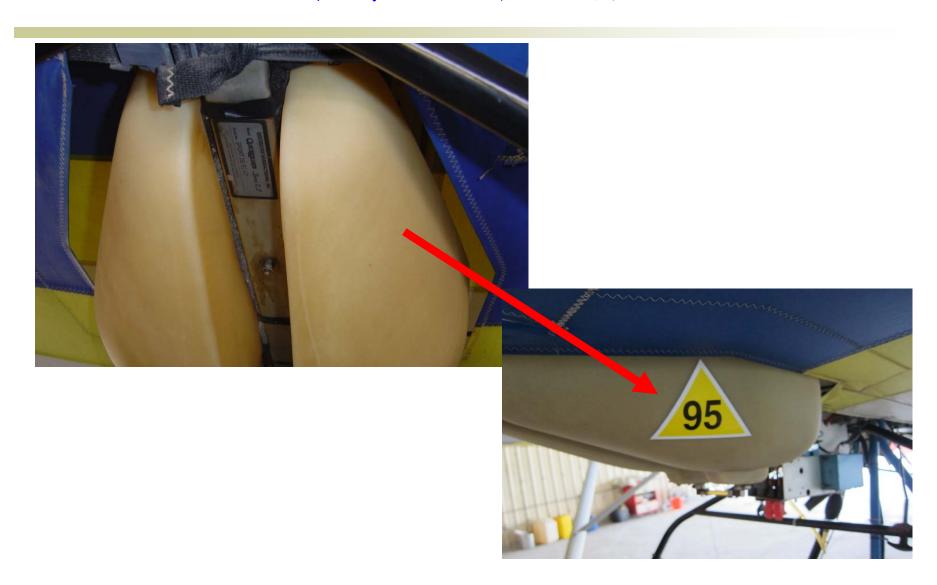
### 未有燃油種類標示

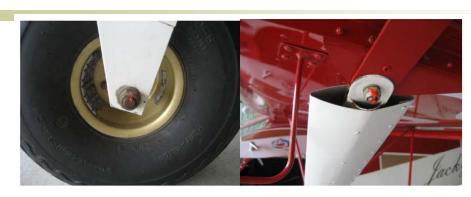
### 搭接螺栓未施塗Torque Seal

改正後情形

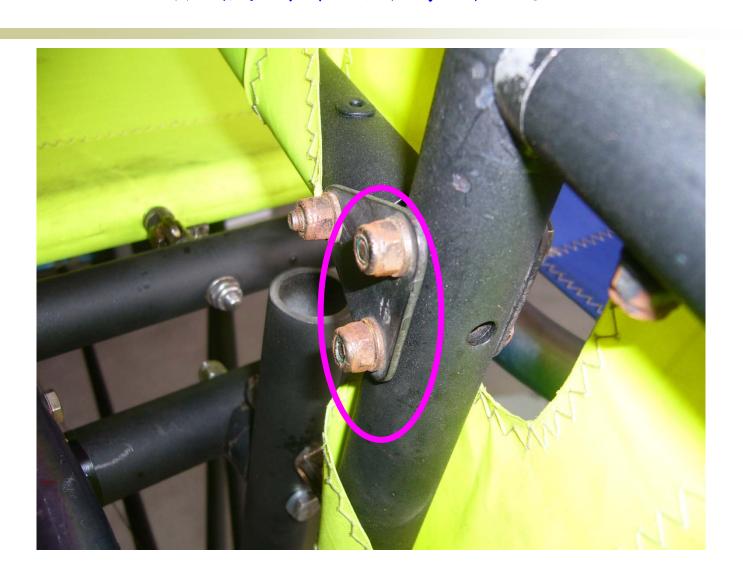
## 搭接螺栓出牙不足

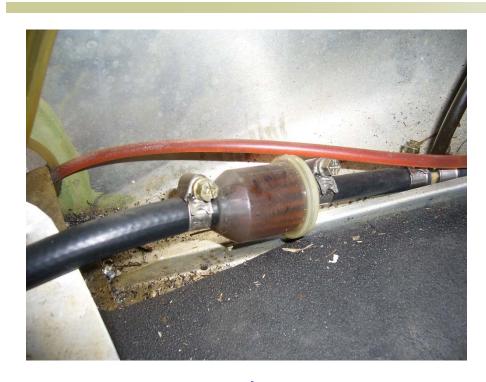
# 油濾不良

不良

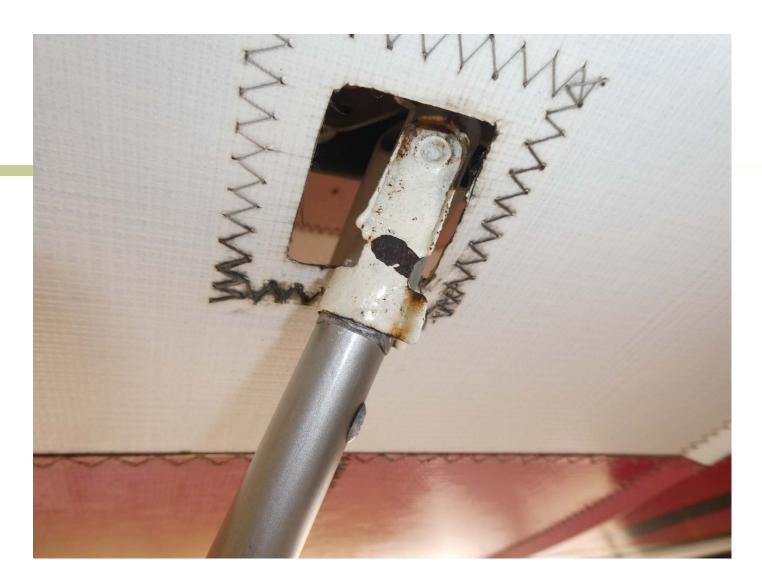
機翼快拆插銷銹蝕

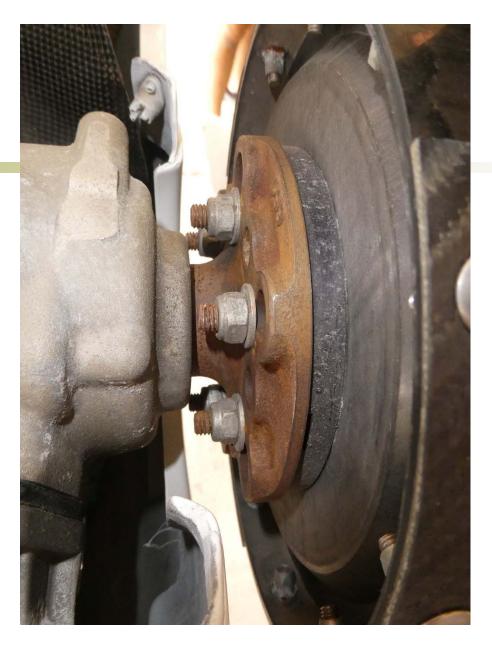
螺旋槳傳動軸盤銹蝕

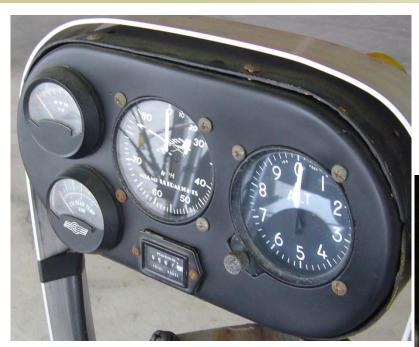
### 儀表板未有操作限制標示

未標示
